RE: Site Inspections; International Uranium; Hecla Shaft, La Sal-Snowball, Pandora, and Redd Block IV Projects; M/037/043, M/037/026, M/037/012, M/037/046; San Juan County, Utah

Date of Inspection: May 1, 2002  
Time of Inspection: about 1:00 to 3:00 p.m.  
Conditions: Mostly clear, 50's, windy  
Participants: Doug Jensen and Paul Baker, DOGM

# **ATTACHMENT**

**M/037/043, M/037/026, M/037/012, M/037/046  
Hecla Shaft, La Sal-Snowball, Pandora, and Redd Block IV**

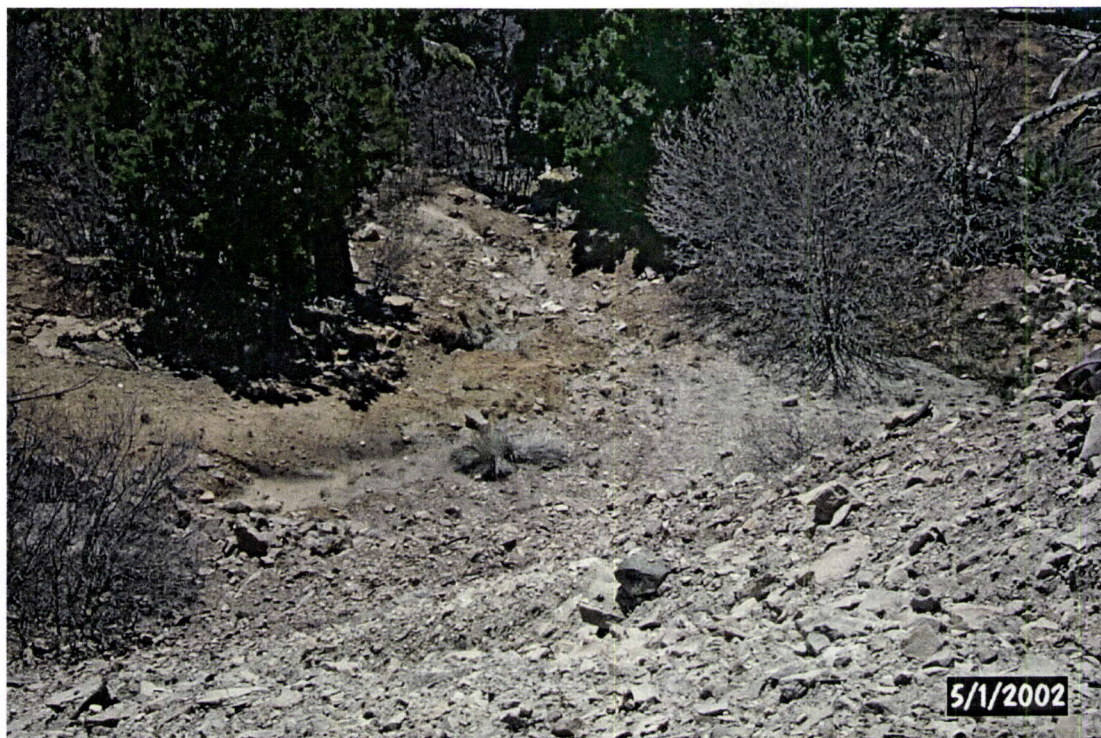
Permit M/037/026 includes both the La Sal and Snowball sites and the Beaver Shaft. At the Snowball site, there has been some erosion from the waste piles (Photo 1). and it appears some of this material has gotten into the drainage (Photo 2). Photo 3 shows some buildings at the Snowball Mine.

Photo 2. Sediment below the waste pile at the Snowball Mine.

The operator should install a silt fence or straw bales in the drainage below the Snowball waste pile to reduce the amount of material getting into the drainage. Otherwise, we have no other long-term maintenance suggestions.

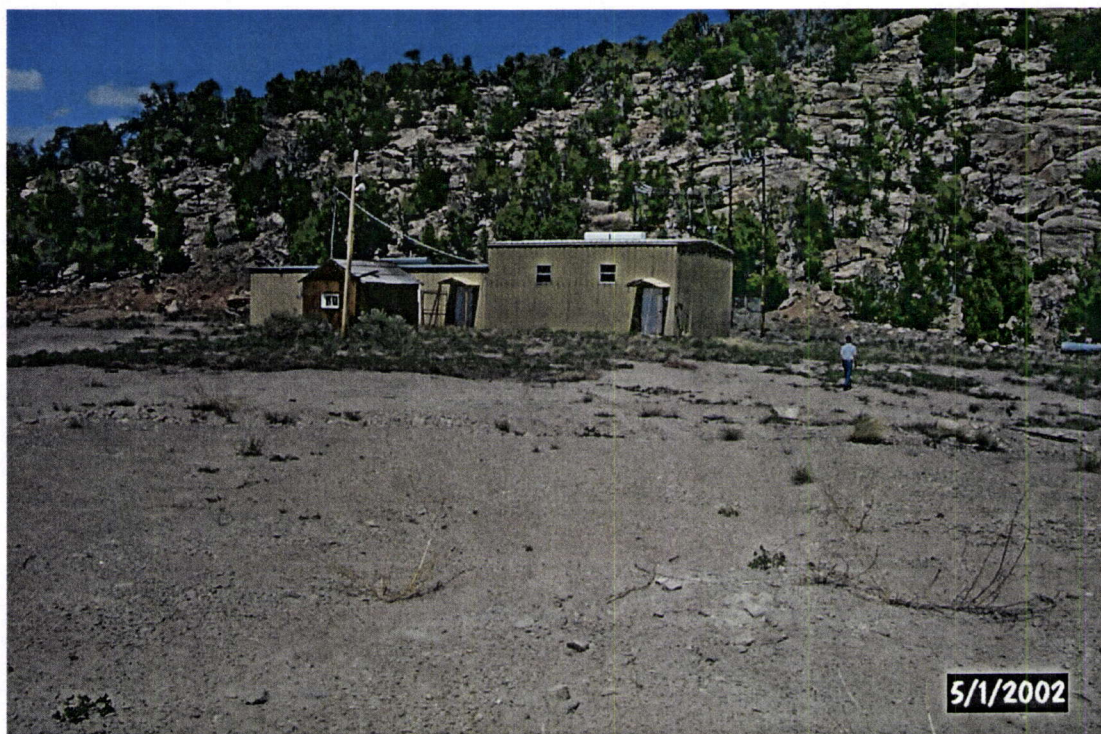
Photo 3. Buildings at the Snowball Mine.

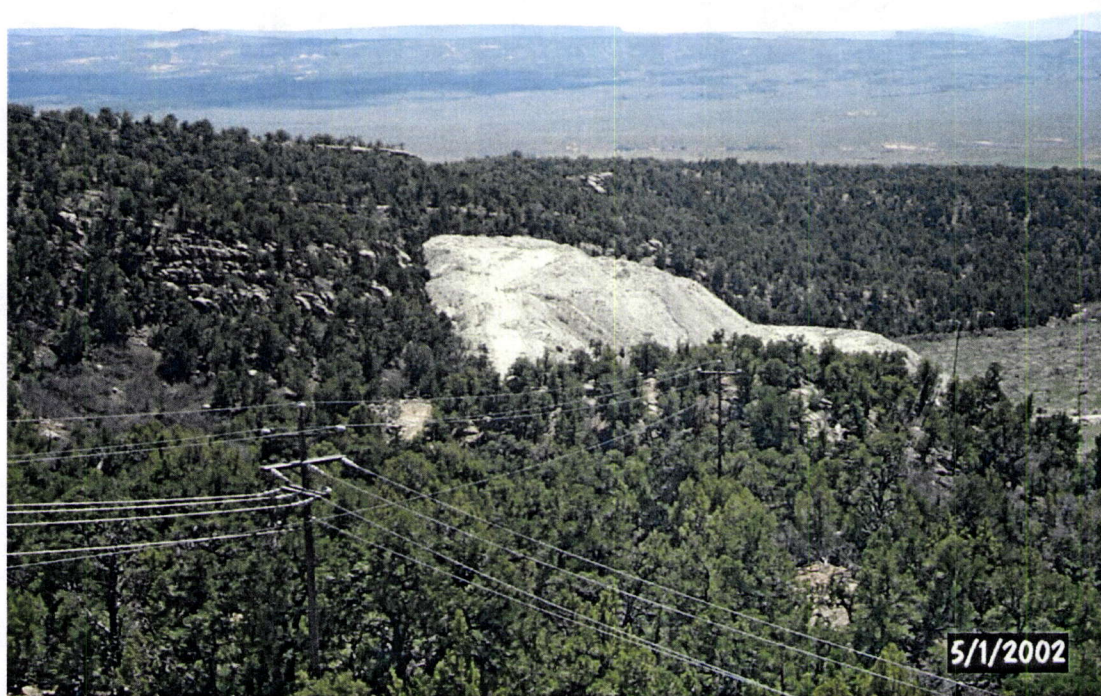
The Snowball and Pandora Mines are both in a canyon, and there would be limited space available to regrade the waste piles although there is some (Photo 4). In places where the waste was stable, there were perennial grasses, sweet clover, small burnett, and other forbs. This indicates the material has some capability of supporting vegetation if it is stable enough for the vegetation to become established. At the site east of the Beaver Shaft (Photo 5), there had been some cattle, and there was also quite a bit of vegetation establishment. It appeared from this that manure would help vegetation establishment on the waste if the waste is used as a growth medium.

Photo 4. Pandora Mine viewed from the Snowball Mine.

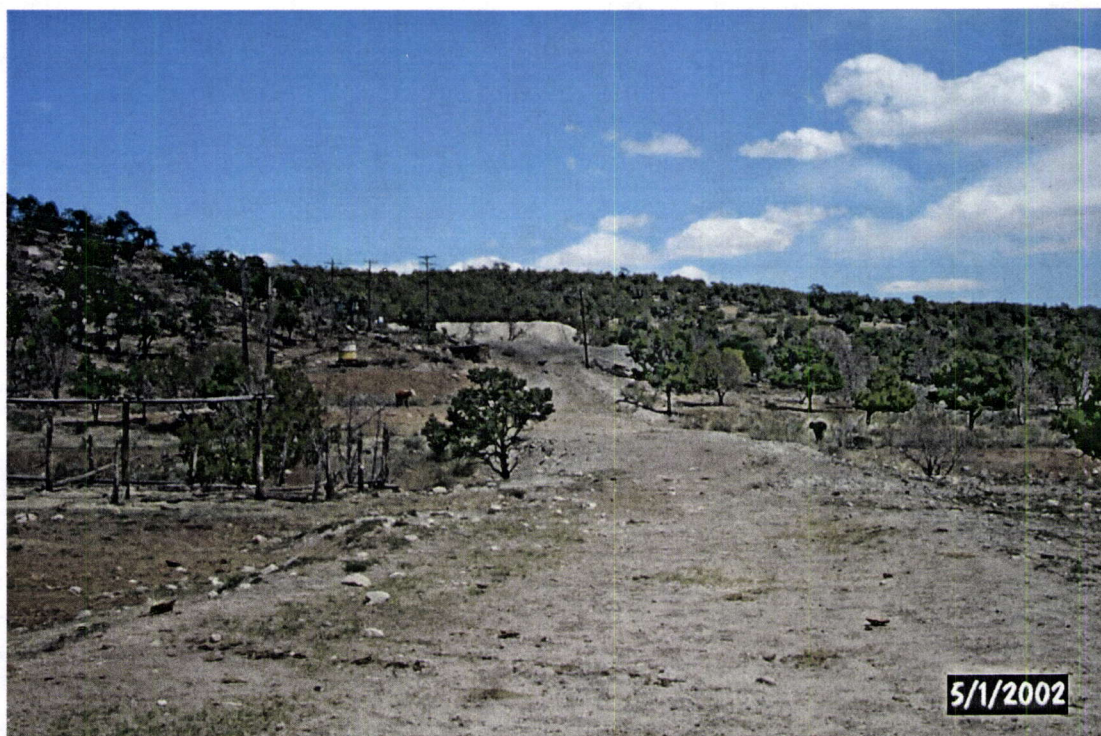
The Beaver Shaft is just north of the town of La Sal, and the headframe is easily visible from the town. There is one road leading north from the town. Take this road then turn west where it comes to a T. There is additional disturbance to the east of the T, and the entire road up from La Sal is included in the disturbed area.

Photo 5. Disturbed area east of the Beaver Shaft.
